**Project No.** **41587-02**

**Subject:** **Erosion-Corrosion of Copper Pipes  
in Hot Water Reticulation Systems**

**Date:** **25 January 2012**

# Erosion-Corrosion of Copper Pipes in Hot Water Reticulation Systems

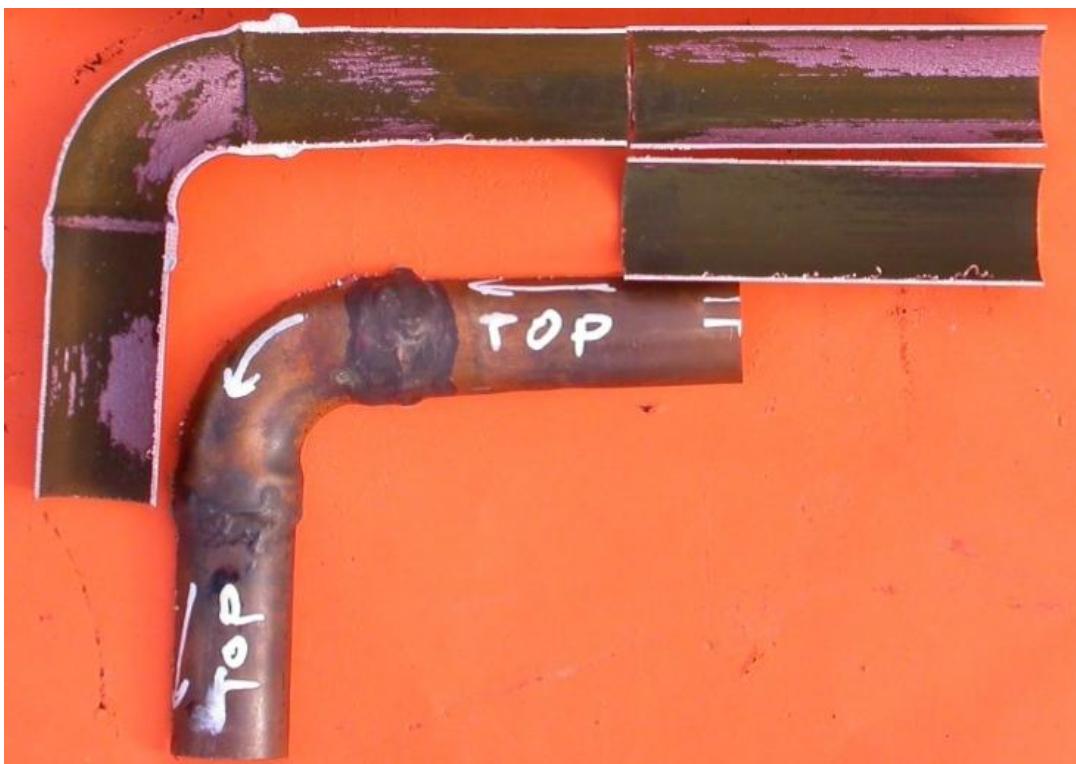
*Figure 1: Overview of pipe samples suffering from Erosion-Corrosion. In this light the attacked bare metal areas show as bright pink while the darker brown regions are the oxide scale.*

In one of the investigations described above, unambiguous Erosion-Corrosion was observed in a straight section of pipe remote from bends and joints (some 500 mm upstream of the leaking bend) — see sample in upper-right of Figure 1. This observation constituted compelling evidence that there was a systemic problem, as opposed to a problem restricted to regions of local turbulence. Although the attack did not occur in all parts of the system, it was evident that the conditions were so close to critical that any number of local factors could trigger the Erosion-Corrosion. This was suggestive of excessively high general flow velocity (and/or temperature — see section 3.2 below).

Figure 1, Figure 6 and Figure 7 show clear evidence of the promotion of Erosion-Corrosion by turbulence at the step in the inner wall profile at a joint. On the other hand, there was direct evidence that Erosion-Corrosion had occurred in response to the general water velocity and temperature, in a straight section of pipe where there were no turbulence-promoting features. It follows that, regardless of the probable contribution of rough joint profiles to a majority of leak sites, it was clear that this system had a systemic susceptibility to Erosion-Corrosion due to excessive water velocity and elevated temperature.

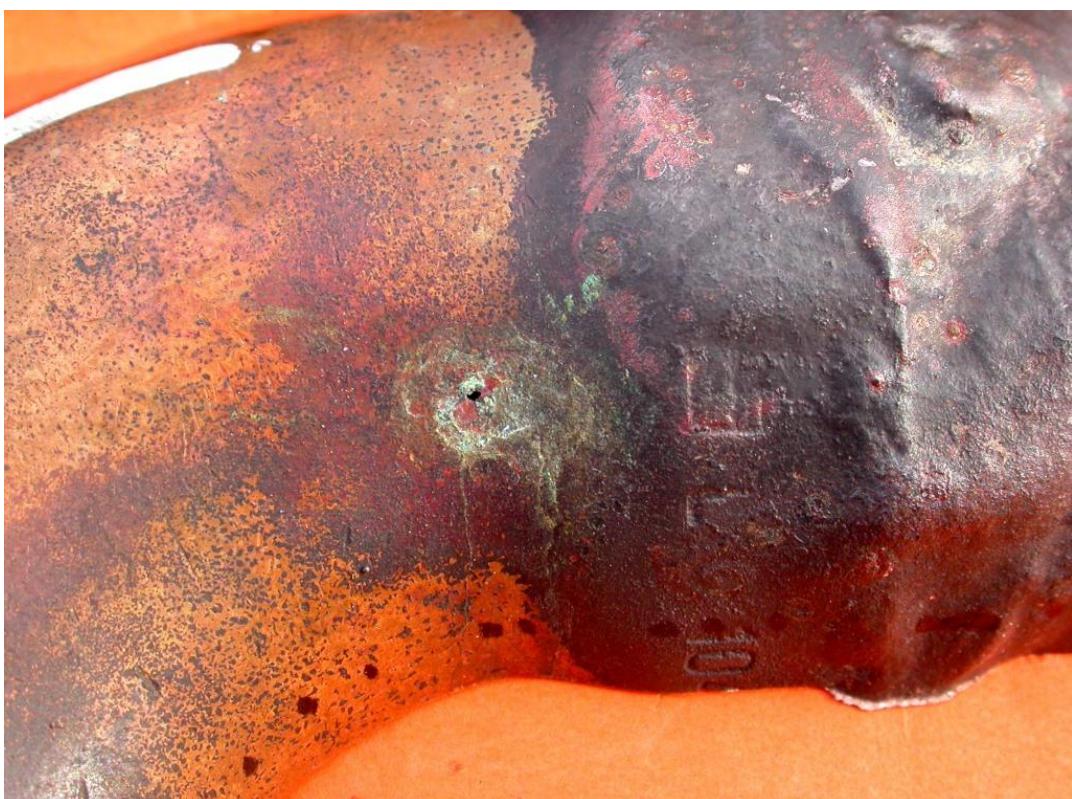
*Figure 2: Pinhole leak at bend, viewed from outside of pipe.*

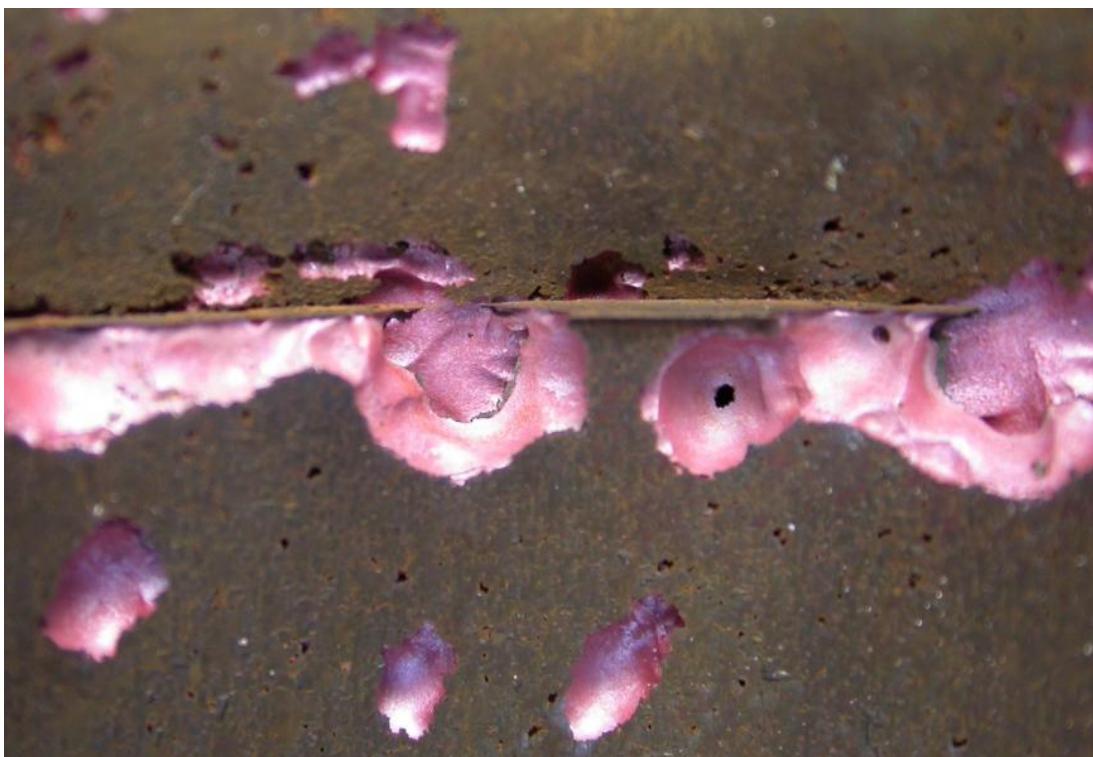
Figure 3: Pinhole leak at joint, viewed from inside of pipe.

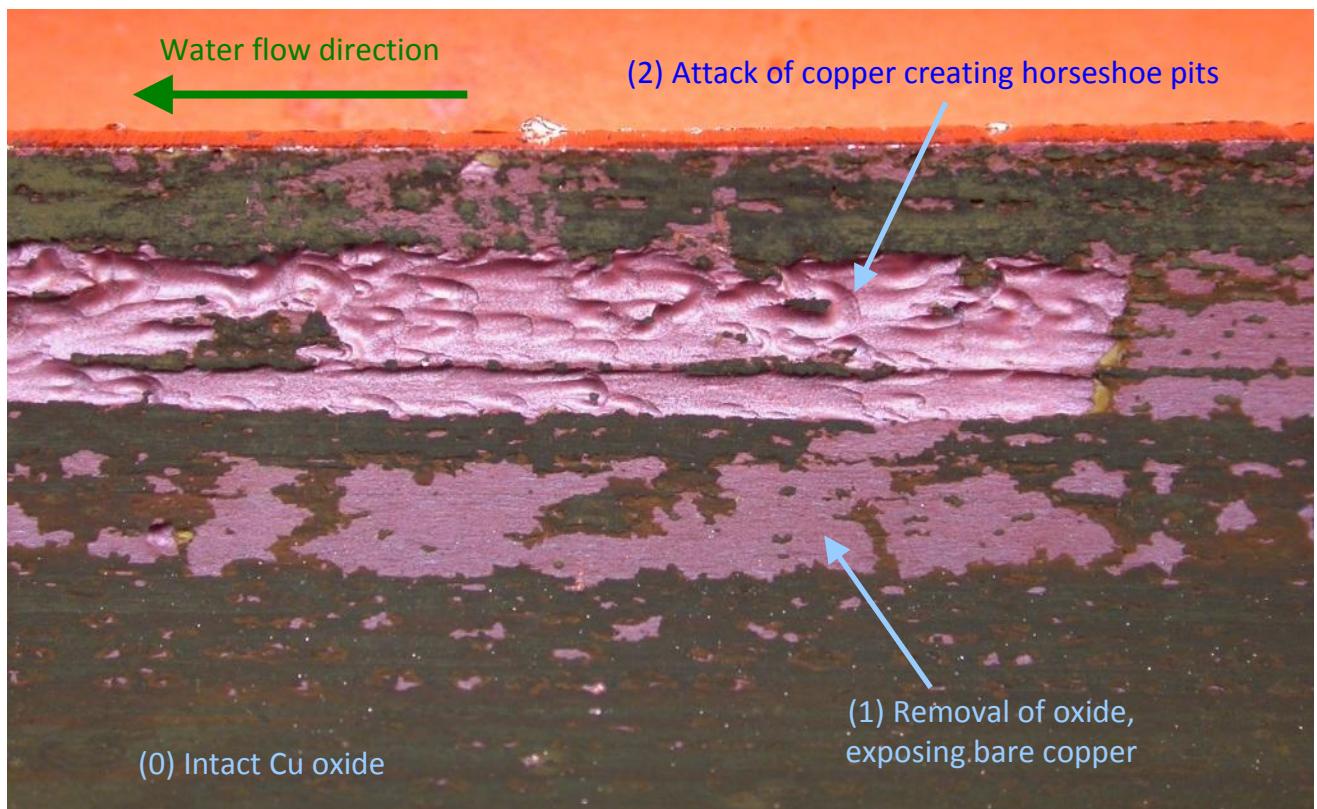
Figure 4: Early stages of Erosion-Corrosion attack. Horseshoe-shaped pits have open end downstream.

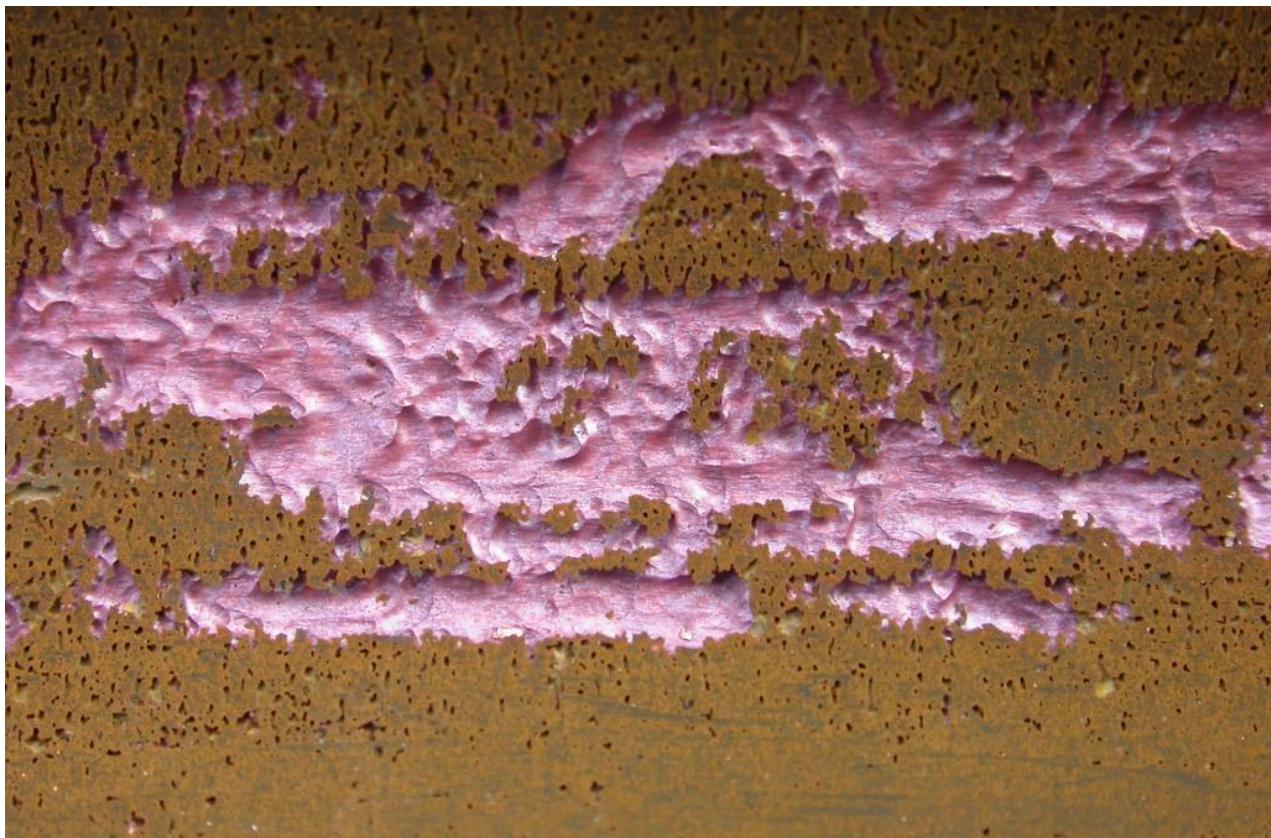
Figure 5: Erosion-Corrosion showing coalescence of horseshoe-shaped pits, with islands of intact oxide between. The latter are deeply undercut.

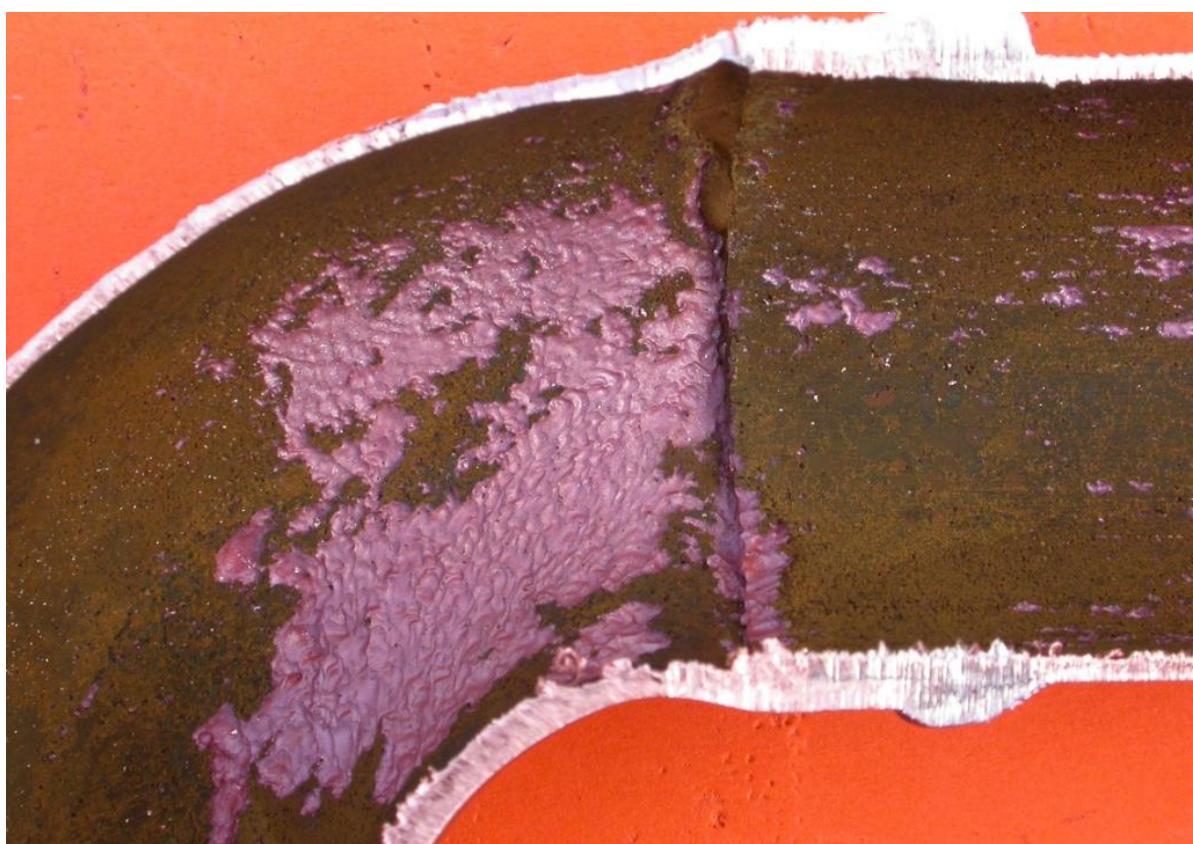
Figure 6: Erosion-Corrosion downstream of a joint, apparently due to turbulence at the joint.

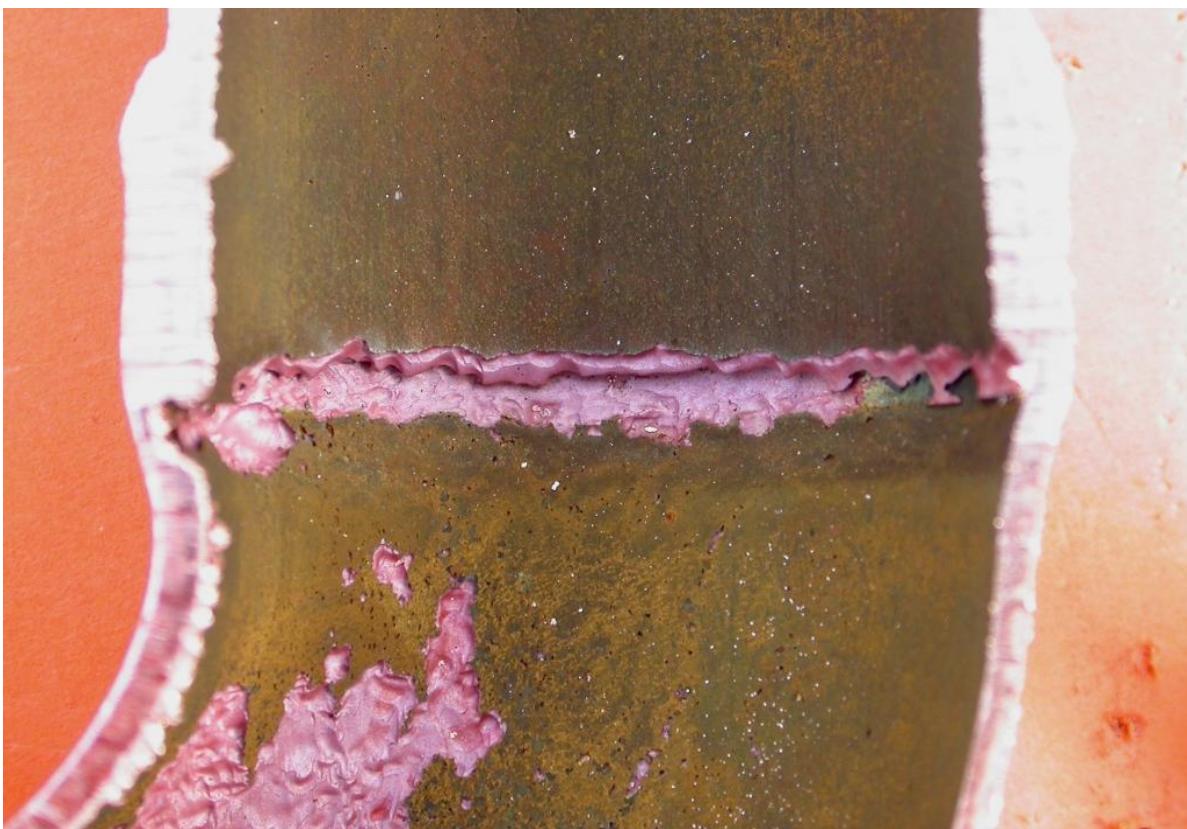
*Figure 7: Erosion-Corrosion at a joint, apparently due to turbulence at the joint.*
