## **BUILDING WATER SERVICES**

**A Seminar to look beyond minimum standards**

### **2 of 3 - Copy of Slides provided by Second Speaker:**

# DESIGN CONSIDERATIONS WHEN USING PP-R IN CHLORINATED HOT WATER SYSTEMS

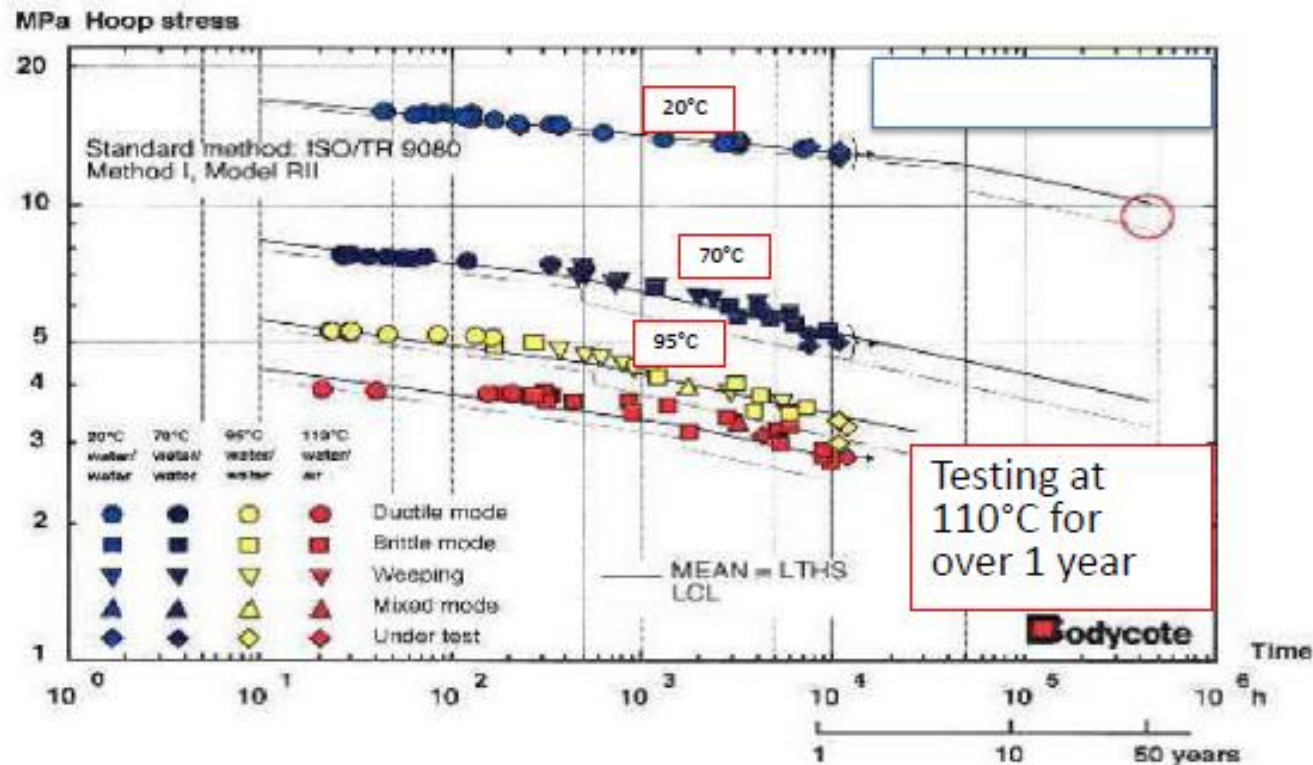
- Strength vs. temperature
- As temperature increases, long-term strength decreases

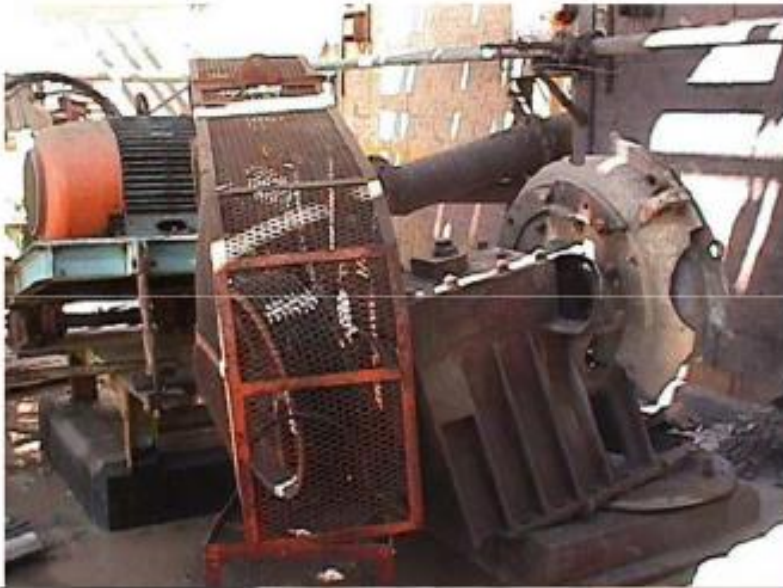
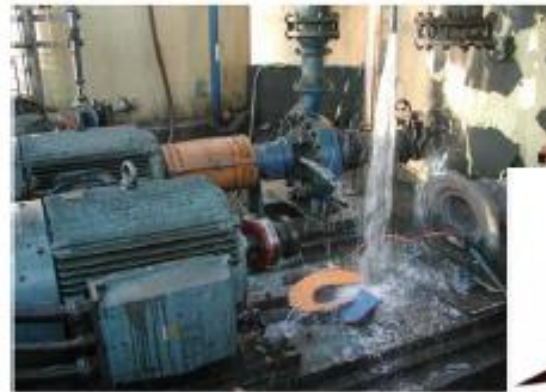
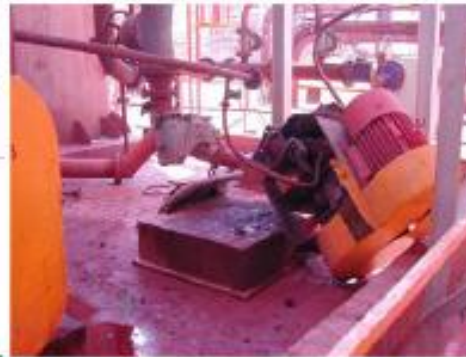
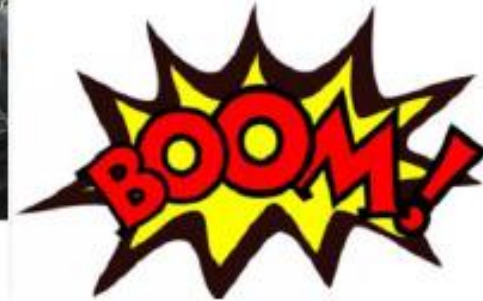
Duty Pump with 'Remains' of Standby Pump

- Sources of excessive temperature
  - Pump deadheading (operating with little or no flow)
  - Temperature rise =  
$$(5.1 \times \text{Pump HP}) / (\text{Vol} \times \text{spec. heat} \times \text{spec. gravity})$$
  - Assume 20 HP pump, 10 meters of 125mm pipe
  - Temperature rise = 2.6°C/min, or 157°C/hr
  - After 2 hours, temperature would exceed ~300°C, and internal pressure would exceed ~4000 kPa!

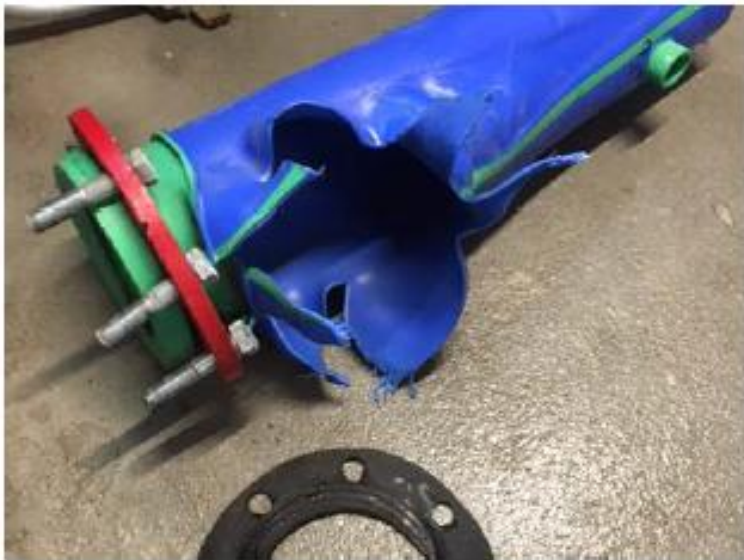
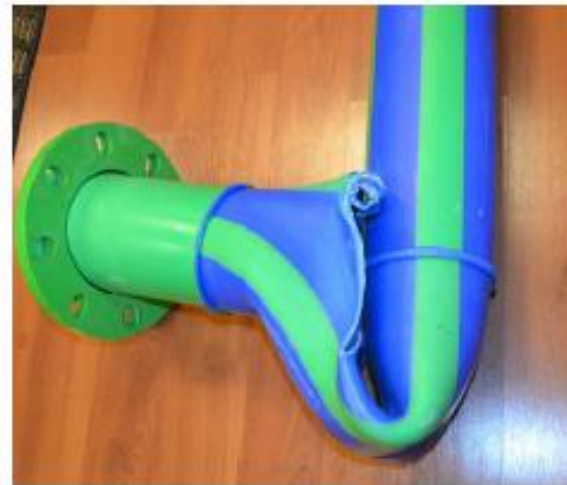
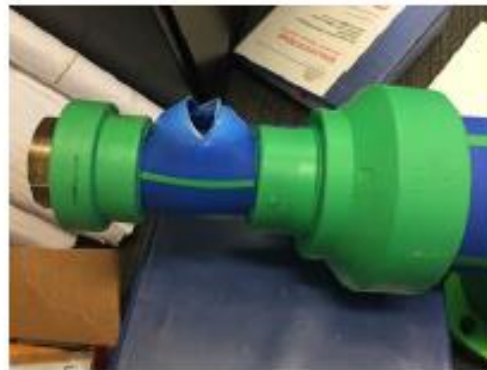
- Sources of excessive temperature
  - Pump deadheading (operating with little or no flow)
  - PP-R piping, pipe rupture, significantly less system damage

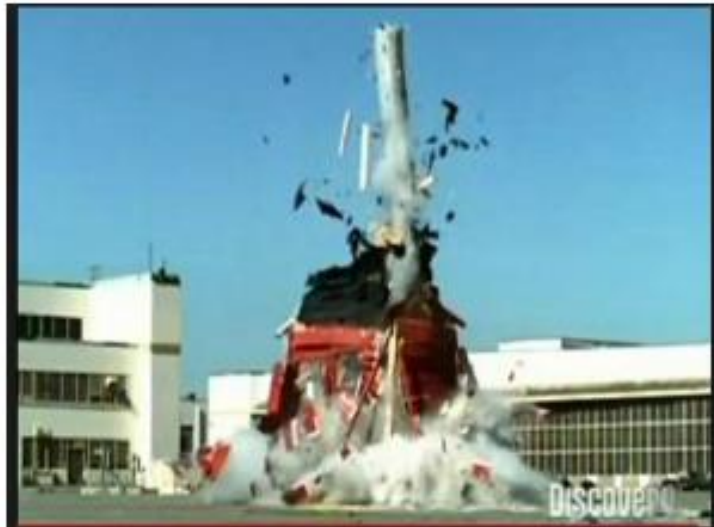
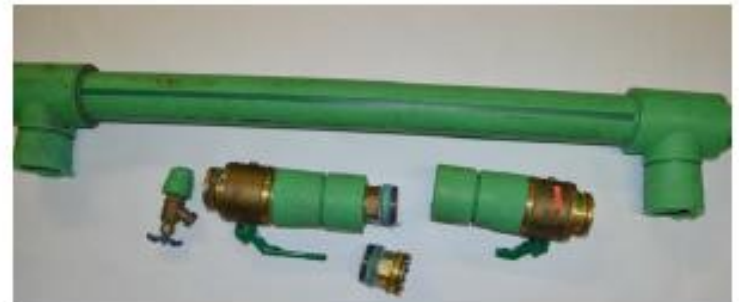
- Sources of excessive temperature
  - Boiler malfunction (**NA Tech Bulletin**)
  - Tests, limits and allowances, ratings
    - Tested at 110°C for > 1 year
    - Pressure ratings include 100 hr @ 100°C (Application Class 5)
  - Operator/User
    - Complaints of lack of hot water
    - Typically due to improper flow balancing or maintenance issue
    - Response is often to increase boiler temperature rather than address root cause
    - Hot water disinfection temperature maintained for extended period rather than recommended 1 hr / day

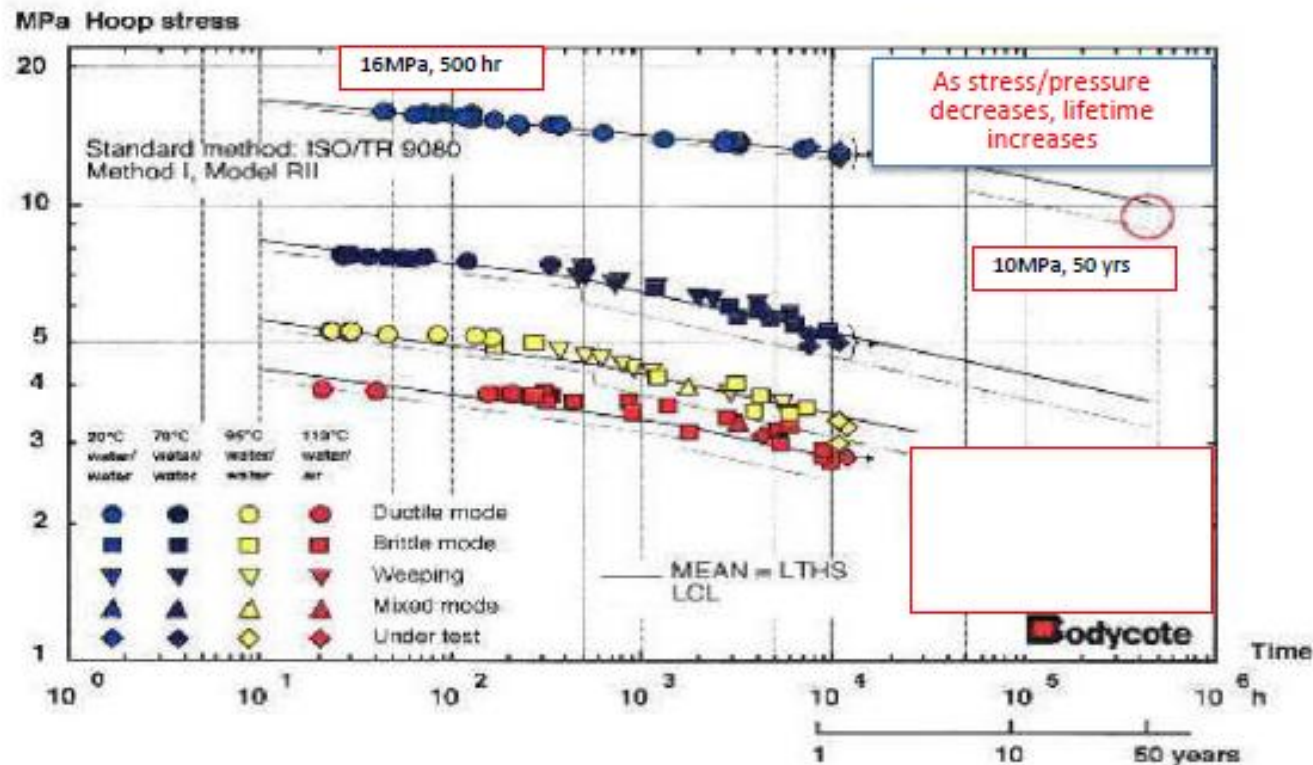
- Strength vs. temperature
- As stress (pressure) increases, expected lifetime decreases (at constant temperature)
- As temperature increases, long-term strength decreases

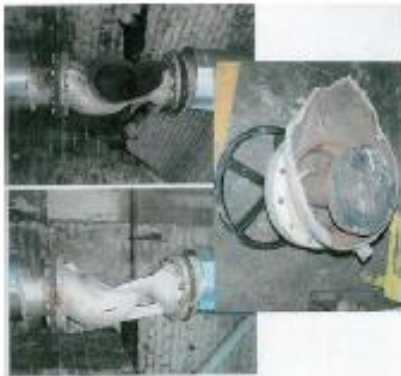
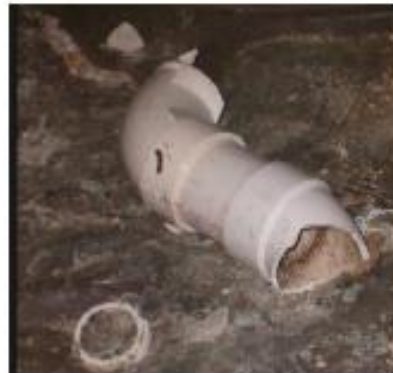
- Pressure surge, water hammer
- Sources:
  - Quick-closing valves;
  - Pump shut-off, start-up if not controlled
  - Sudden demand from nearby buildings
  - Air in pipelines can substantially magnify the pressure surge effects
- Surge pressure (high pressure)
  - Allowance in design, standards
    - Pressure rating + 50% for recurring surge (ie pump start/stop, control valves)
    - Pressure rating + 100% for occasional surge
  - Magnitude
    - Function of velocity change and pipe material:
    - For 1 m/s velocity change:
      - Copper surge pressure = 1260 kPa, Steel = 1400 kPa, PP-R = 550 kPa

$$P_{surge} = a \cdot \rho \left( \frac{\Delta v}{144 g} \right)$$

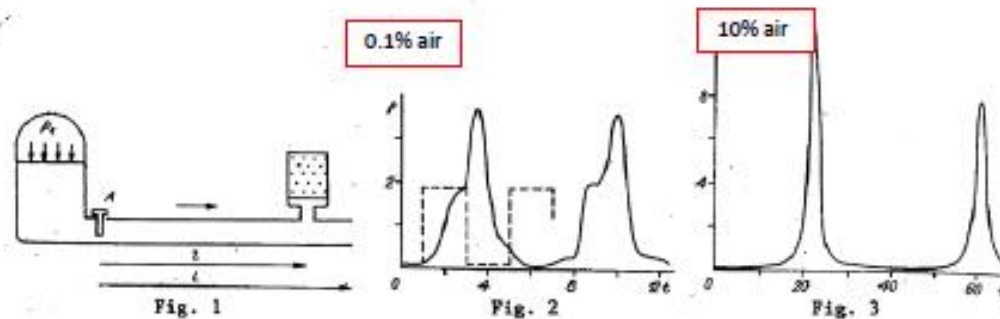
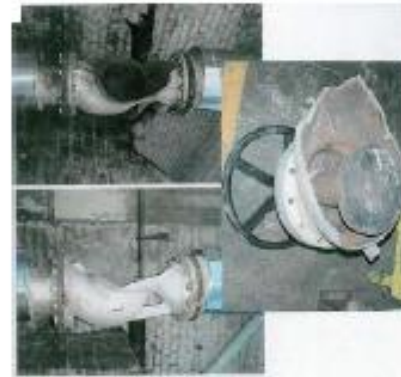
- Pressure surge, water hammer
- Sources:
  - Air in pipelines can substantially magnify the pressure surge effects
  - Without air, surge  $\sim 2\times$  operating pressure;
  - With 10% air pocket, surge  $> 10\times$  operating pressure

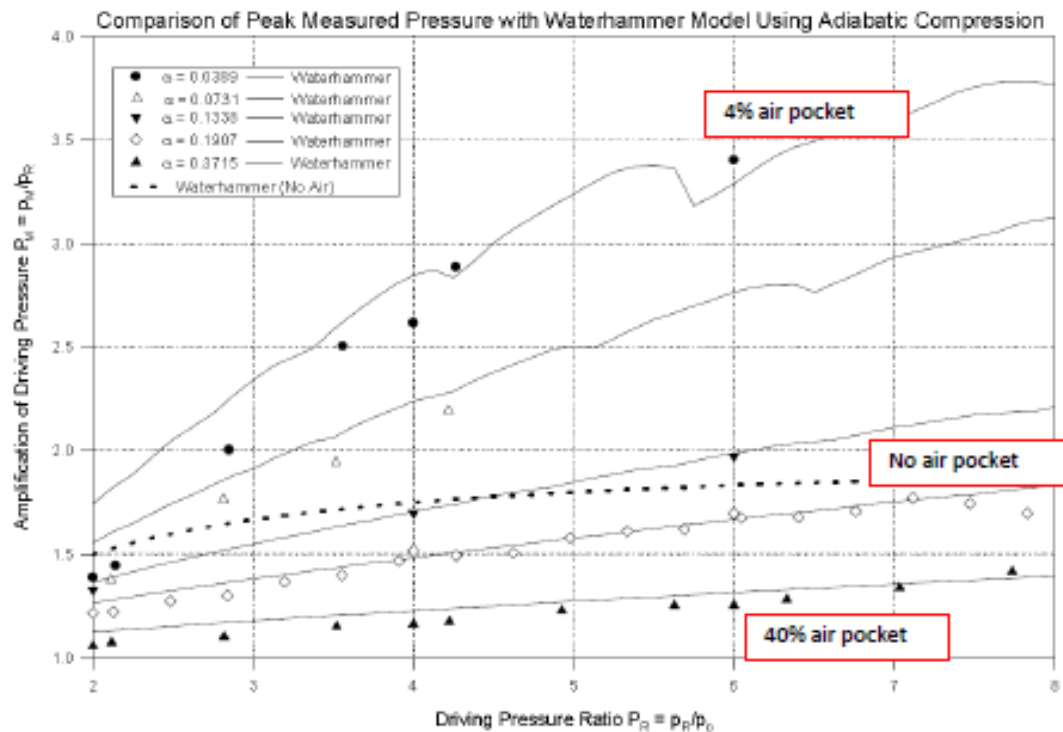
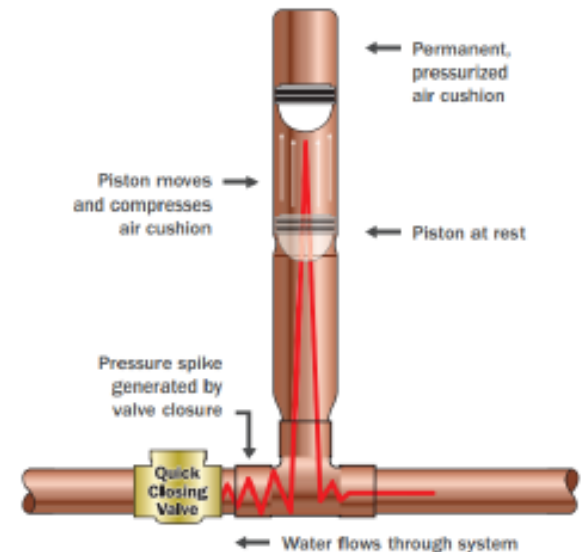
- Pressure surge, water hammer
- If air in pipelines can substantially magnify the pressure surge effects, why do water hammer arresters work?

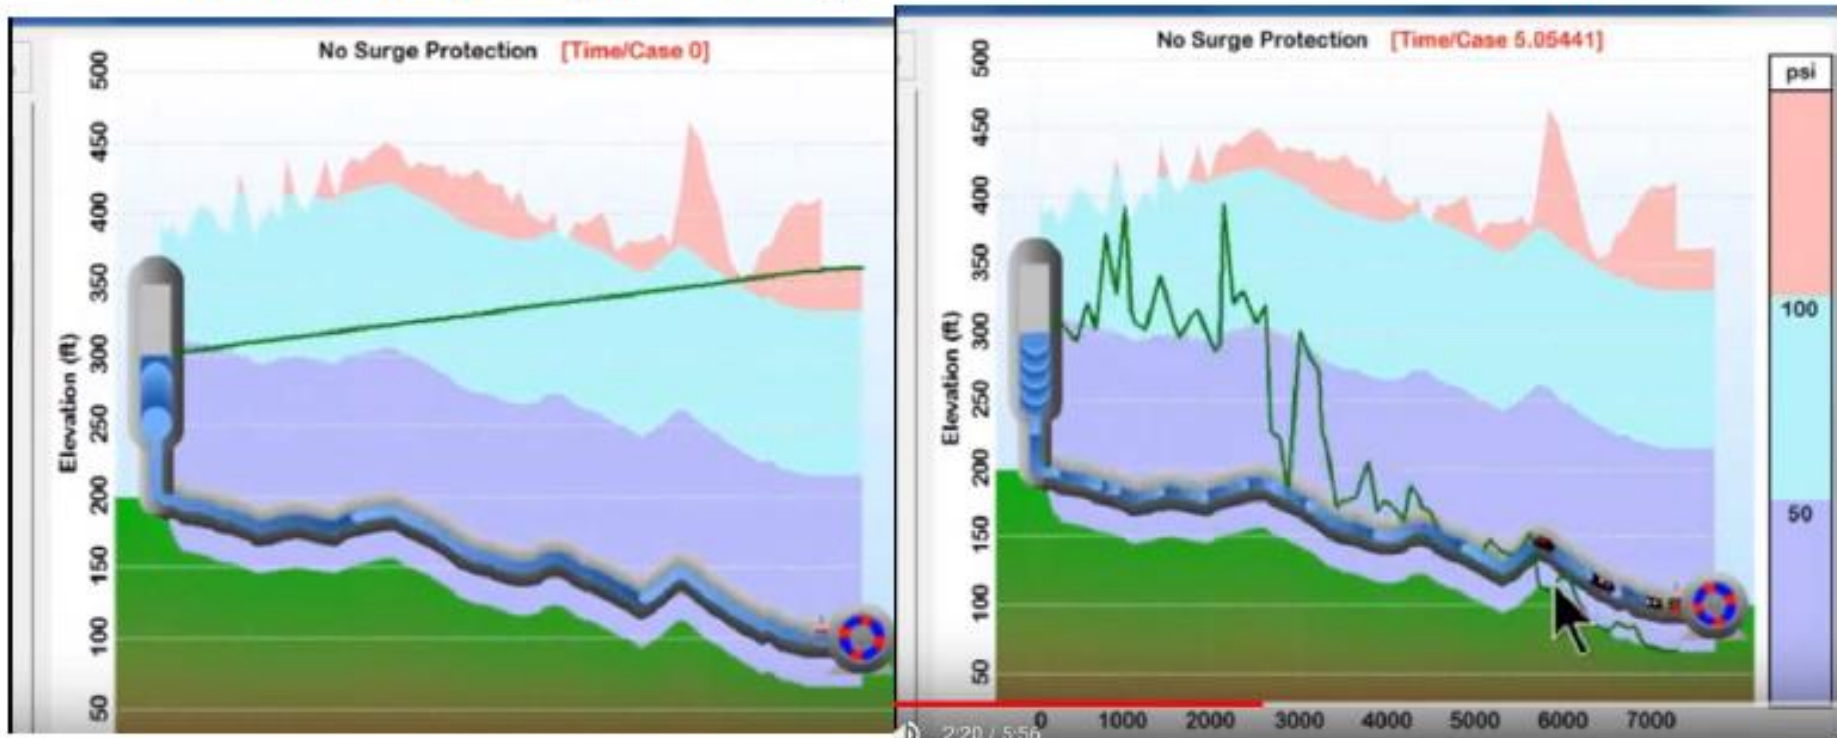
- Conversely, transient pressure surges, water hammer will also cause low pressure events
- Cavitation (low pressure)

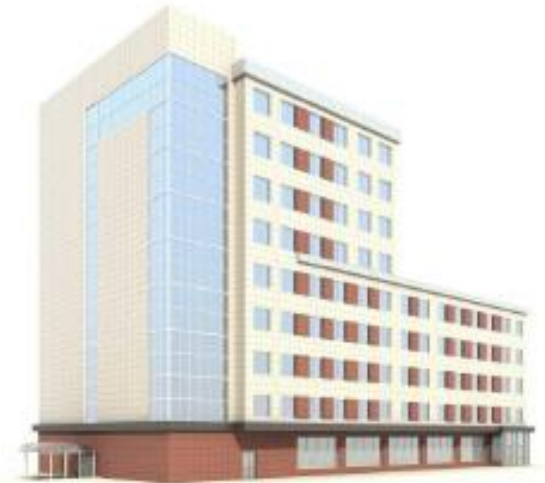
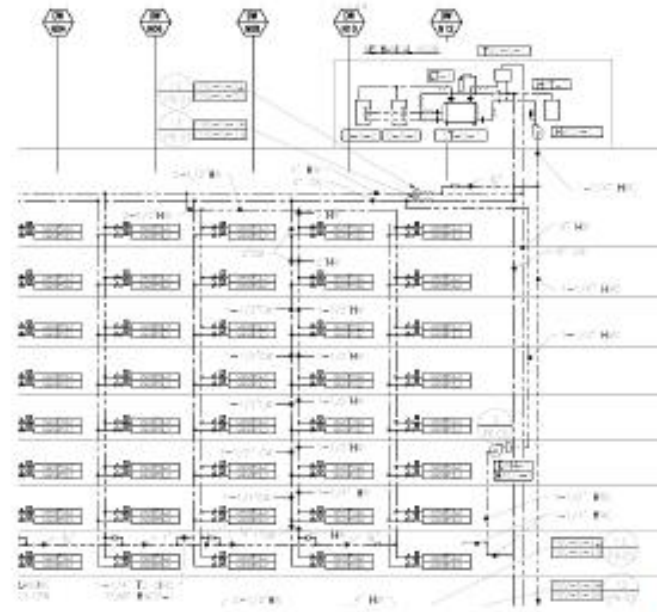
- Balanced flow is critical for:
  - Maintaining proper temperatures,
  - System operation at best efficiency point (energy savings), and
  - Reducing or eliminating damage to piping.
- Common in hydronic heating/cooling systems, information and data readily available
- Much less common in plumbing hot water circulating systems
- Balancing valves
  - Flow restrictors (flow balancing)
  - Temperature maintenance (thermal balancing, flow modulation)
- Oversized circulating pumps, or flow imbalance
  - High velocity in some legs, low or no flow in others
  - High velocity areas can erode/corrode piping, introduce copper into water

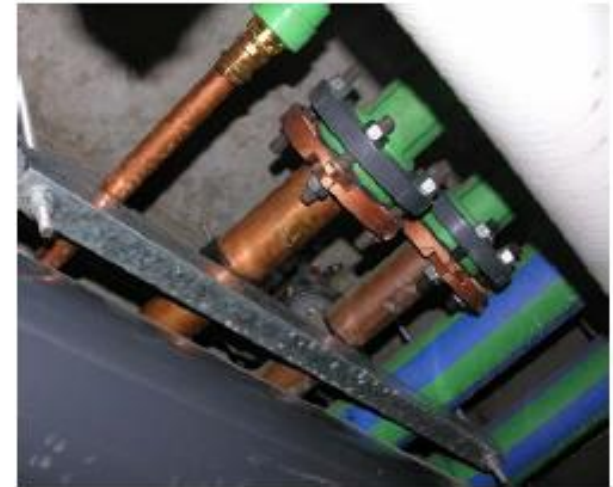
- Copper (cont.)
  - Domestic hot water recirc.
  - Continuous circulation
  - Temperature >120°F (49°C)
  - Active copper erosion/corrosion
    - Erosion/corrosion
      - Flow-induced corrosion
      - Corrosion due to aggressive water
      - Erosion, cavitation
    - Flow velocity in excess of Copper Development Association (CDA & Canadian CBDA) recommendations;
    - Piping undersized, multi-speed pump at wrong setting;
    - Aggressive water
      - pH, alkalinity, carbonate, TDS, chloramine/chlorine, dissolved oxygen
  - EPA, WHO, European regulatory action levels

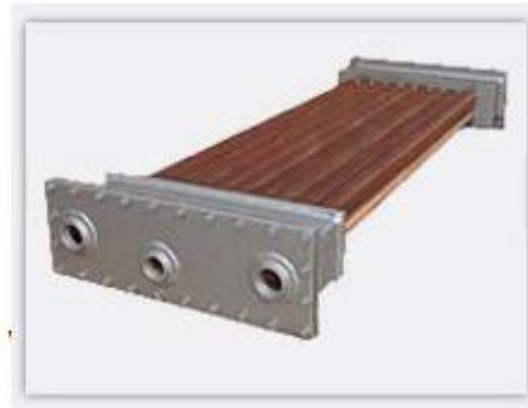
- Copper (cont.)
  - Copper tube boilers
    - Not generally an issue
    - Designed to avoid excessive copper tubes
    - Can still be problem in aggressive/corrosive water conditions, prefer alternate materials (SS or Al)

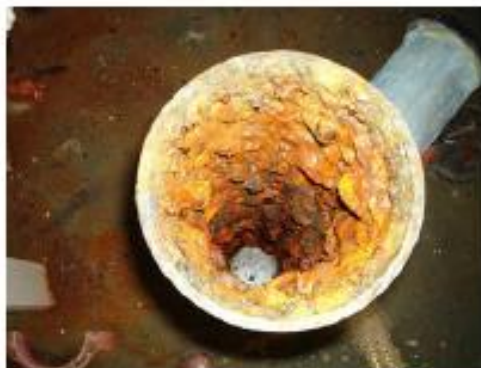
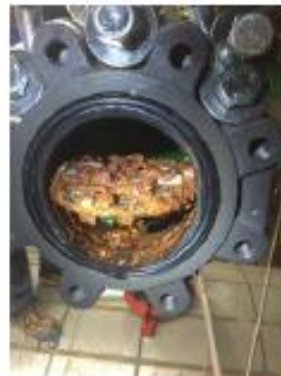
- Iron reacts quickly with other elements in the water to form oxides and calcium/silicate compounds that precipitate out of solution to form scale, tuberculation, rust
- Iron less noble than copper (galvanic series)
- See chemical resistance charts, iron chloride, iron hydroxide, iron nitrates, sulfates

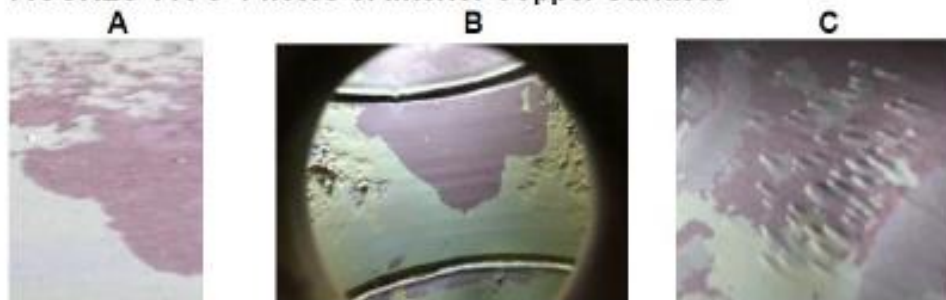
FIGURES 1 A-C Photos of Interior Copper Surfaces

- Research
  - Microscopy, FTIR, XFR (scale, oxidation layer)
- Conclusions
  - Erosion of scale and oxide layer on copper, exposing copper to water and corrosion
  - Calcium Carbonate Precipitation Potential indicates scale would be sufficient to protect copper under proper flow conditions

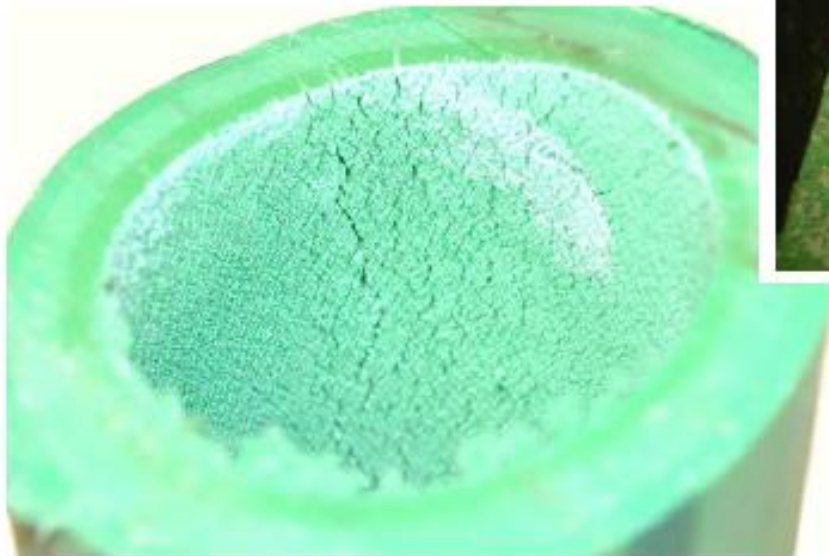
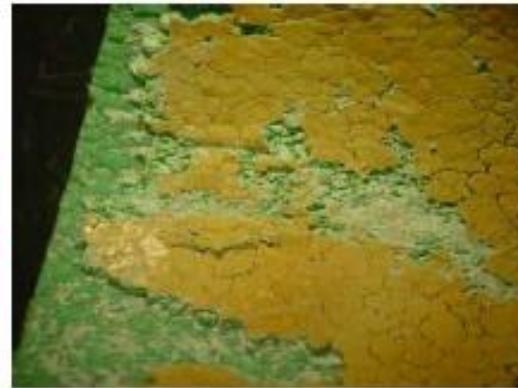
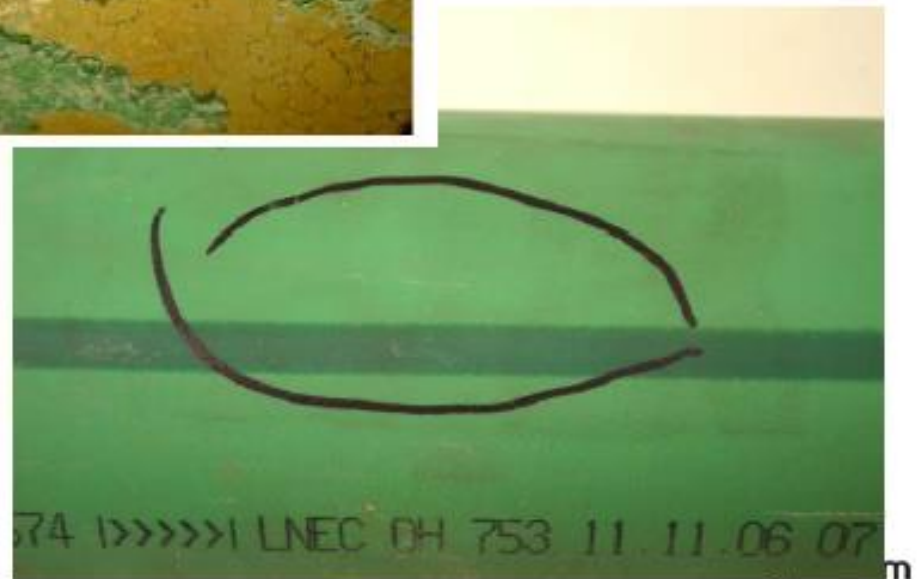
- Oxidative degradation, severe interior cracking, but only small exterior crack at leak

- Extensive micro-cracking on interior,
- rough interior surface around entire pipe, not localized,
- green or white residue on inner surface that will come off on finger,
- typically additional copper/brown/red color residue in some portions,
- o-rings/gaskets will also be degraded

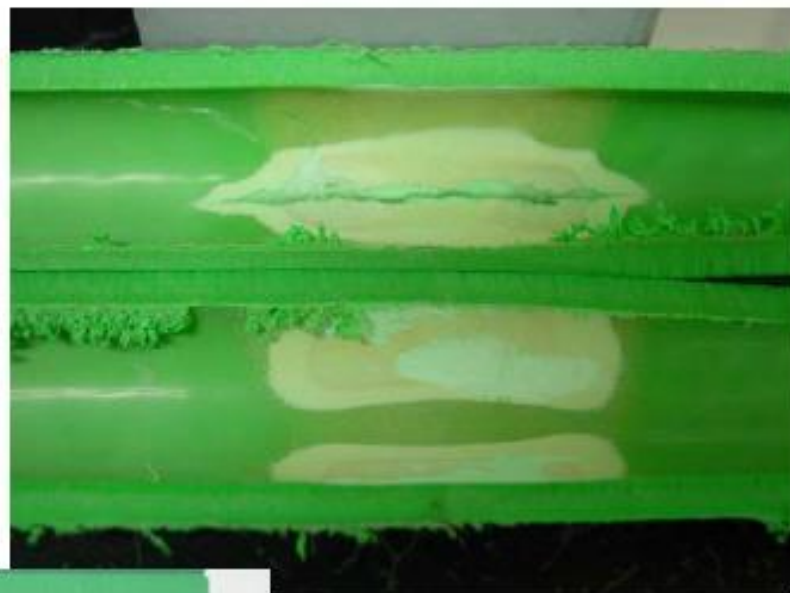
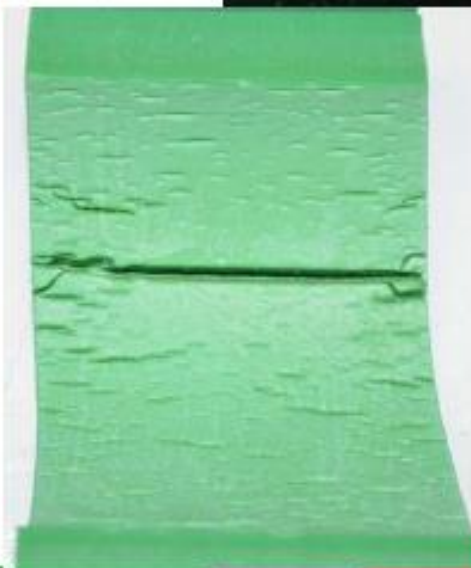
- Mechanical stress under elevated temperature, over-tightened clamp
- Cracks, degradation at clamp location
- Thermal oxidation, excessive temp

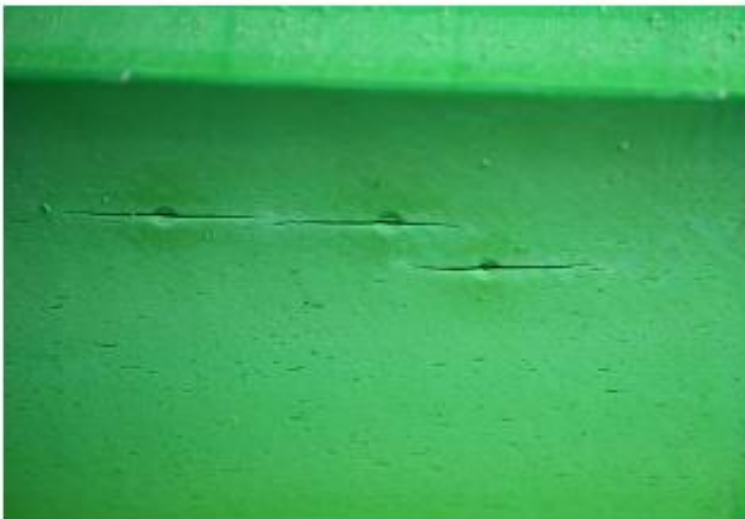
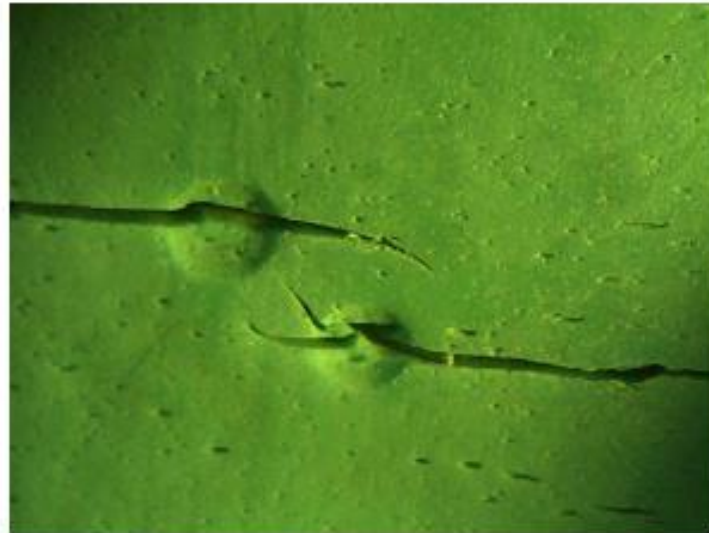
- Cavitation-initiated cracks, degradation
- Cavitation “dimple” at crack origin
- Localized excessive stress, susceptible to crack propagation and oxidative degradation

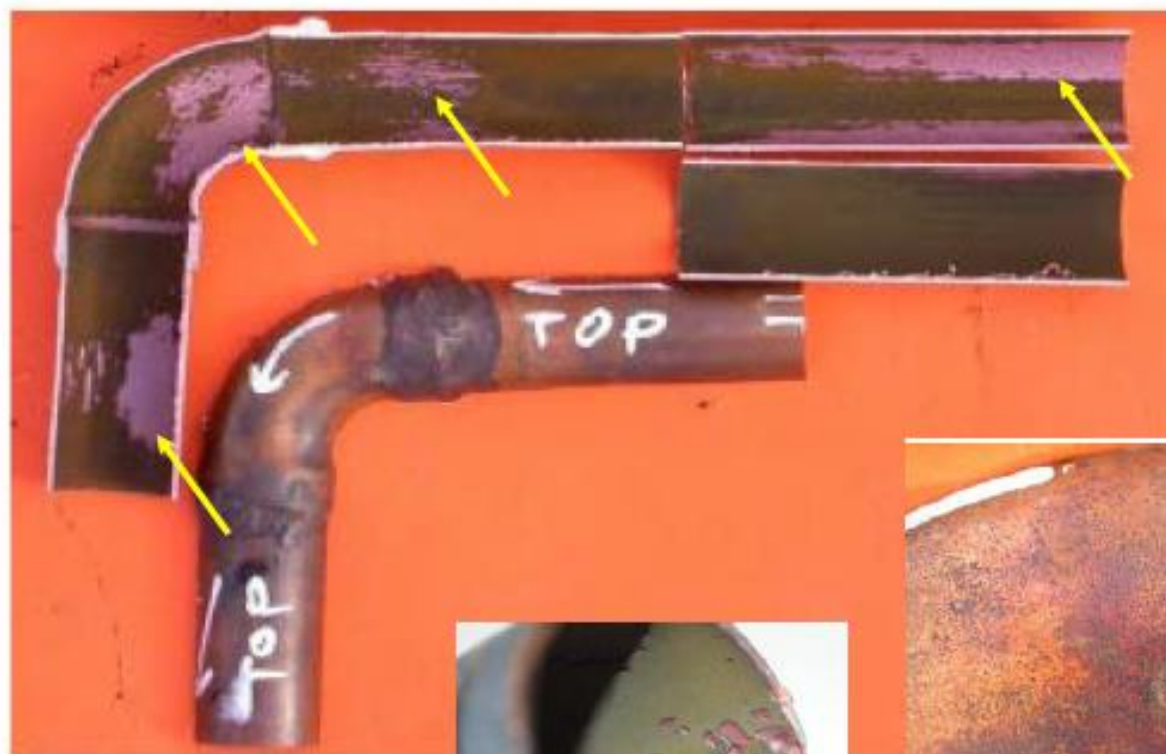
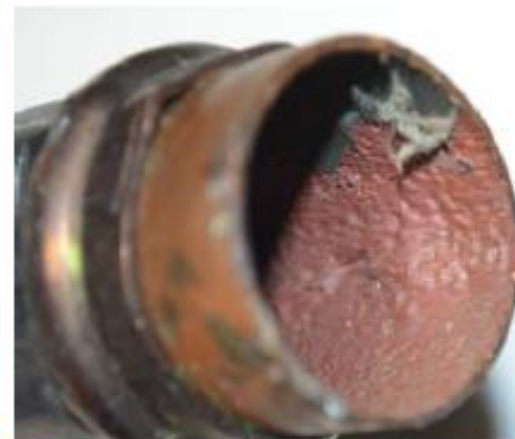
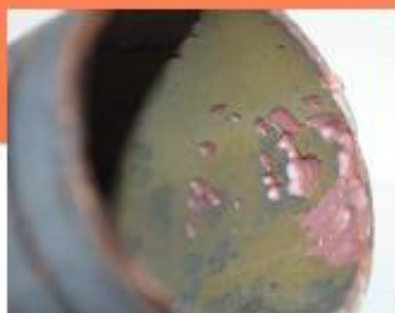
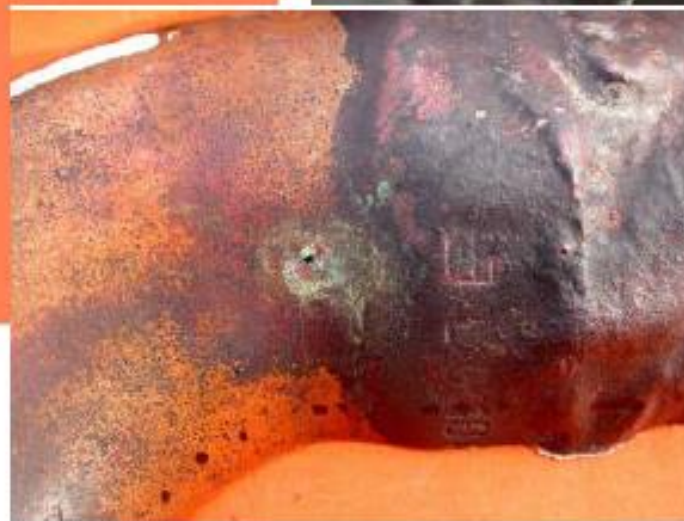
- Copper erosion/corrosion, pinhole leaks
  - In most cases, copper leaks occur and piping must be replaced prior to any leaks in Aquatherm piping. This should be considered a warning sign in mixed systems.

Figure 3: Multiple leaks in a mixed system from corrosion and erosion

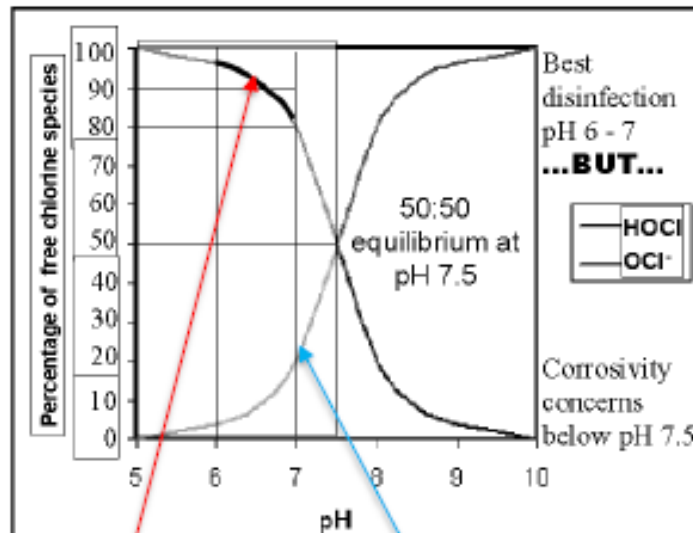
Free Chlorine Distribution with pH

Hypochlorous acid, HOCl

Hypochlorite ion, OCl<sup>-</sup>

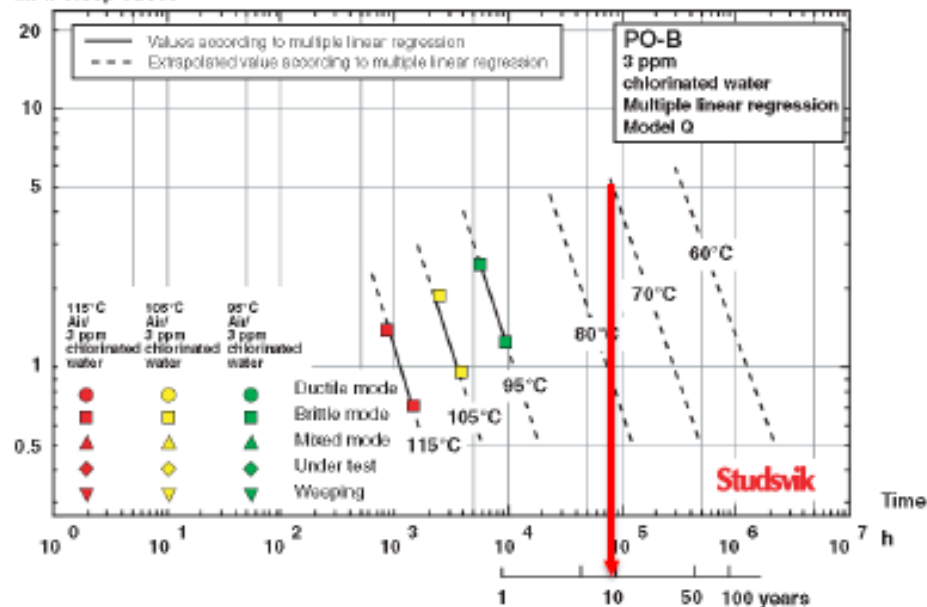
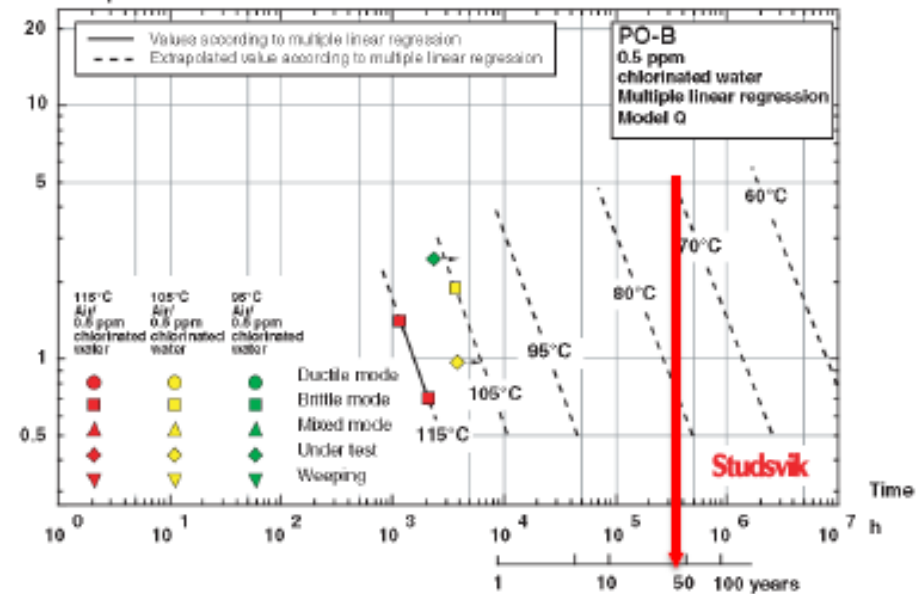
MPa Hoop stress

$$pressure = \frac{2 * (hoop stress)}{(SDR - 1)}$$

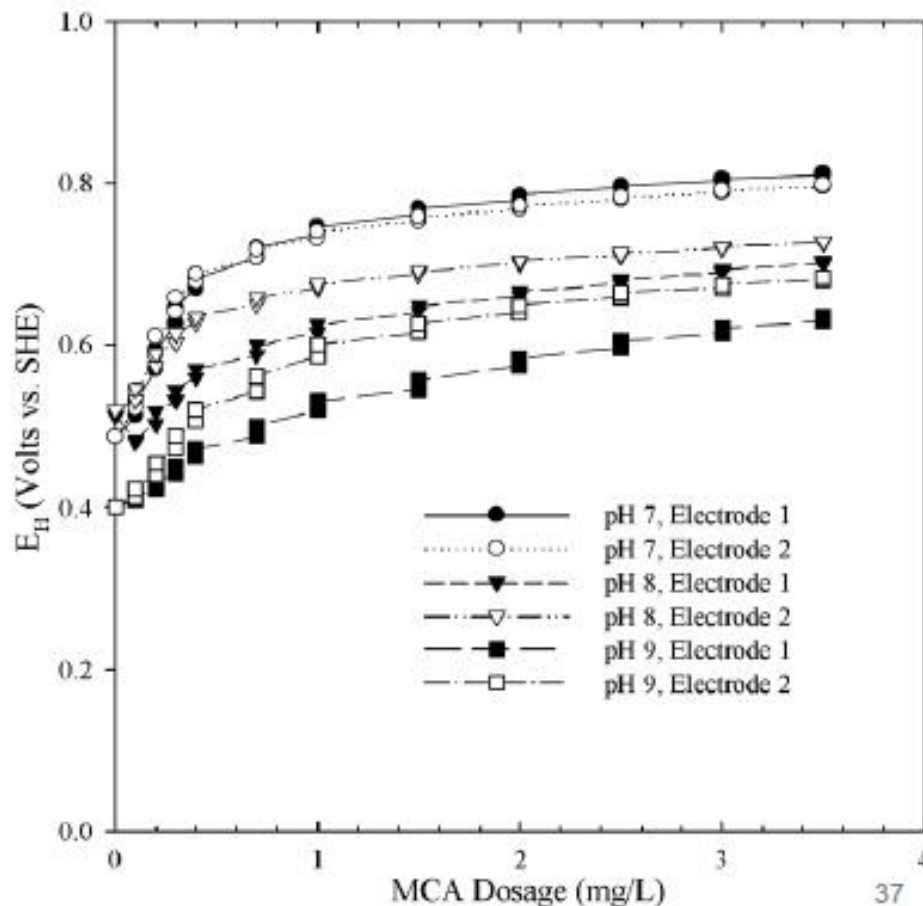
# Chlorine level, ORP

$$E_H = E^o - \frac{RT}{nF} \ln(Q)$$

$$E = E^o - \left( \frac{0.05916}{2} \right) \log \left[ \frac{(OCl^-)(H^+)^2}{Cl^-} \right]$$

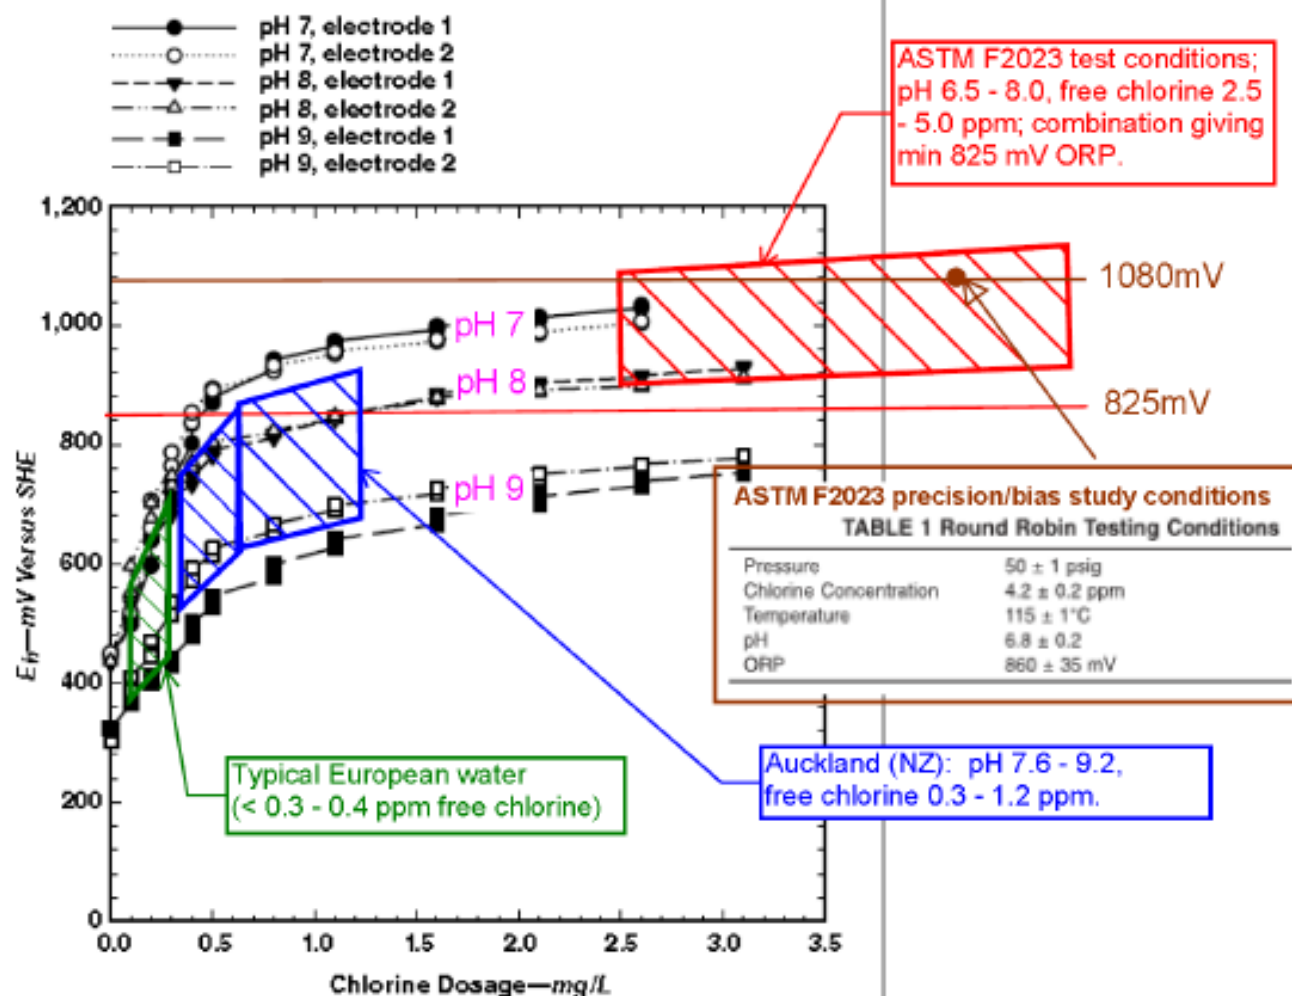
**FIGURE 4** Effect of chlorine concentration and pH on  $E_h$

$E_h$ —half-reaction electrode potential (measured in millivolts),  
SHE—standard hydrogen electrode

Dissolved inorganic carbon = 5 mg/L C; temperature = 23°C

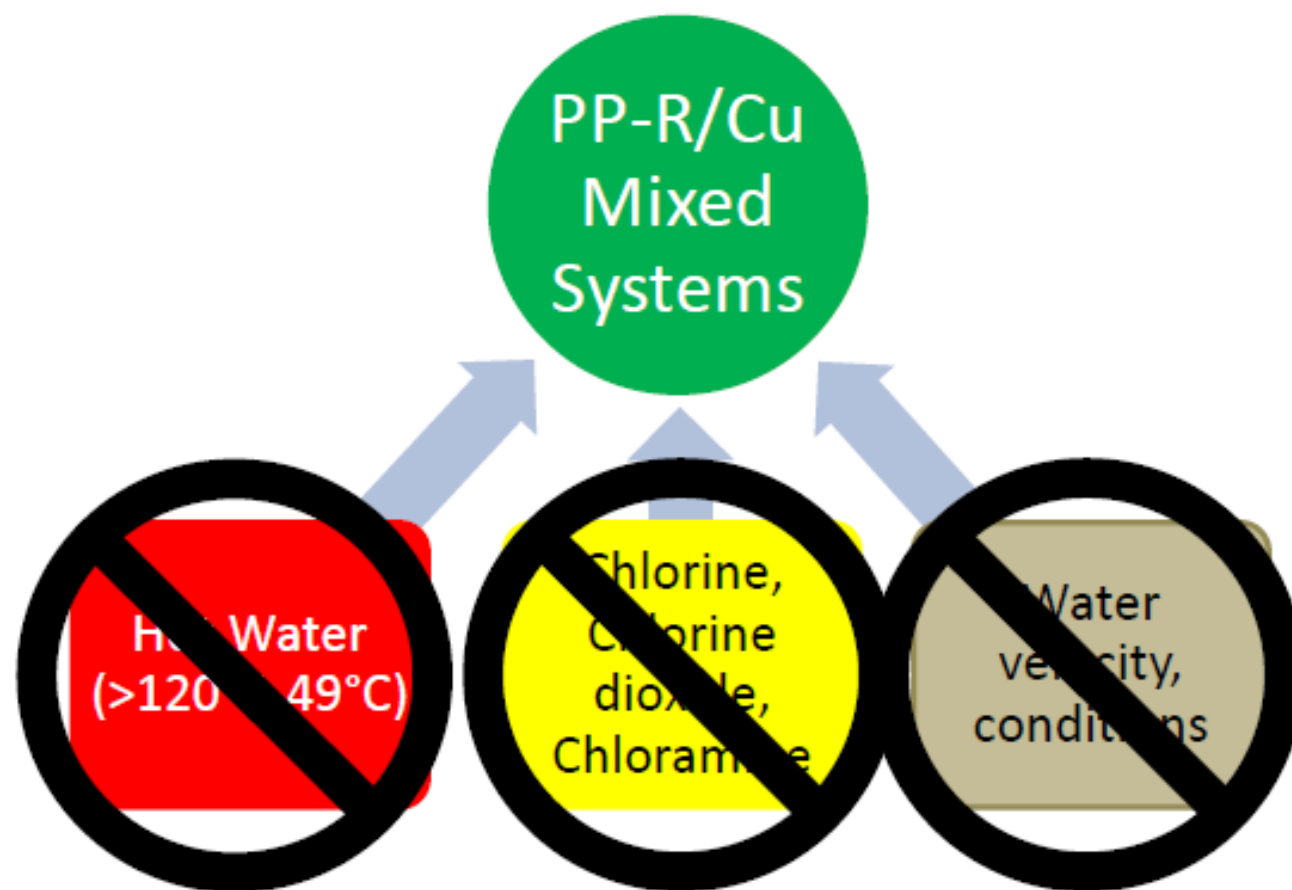
# Summary

Domestic cold water systems, installation temperature, water  
 Hydronic Heating – OK, no replenishment of chlorine  
 Chilled water, condenser water, etc.

- First seen in 2008-09, nothing in prior 30 yrs
- Must have combination of copper, chlorine, and high temperature
- Copper source is erosion/corrosion of piping; simply having copper or brass components in system is not an issue
  - Water velocity
  - Turbulence (fittings)
  - Aggressive water chemistry
